# Inspection Report

Report Number: 578050

Date of Inspection: 6/21/2023

1975 Mercedes-Benz Unimog

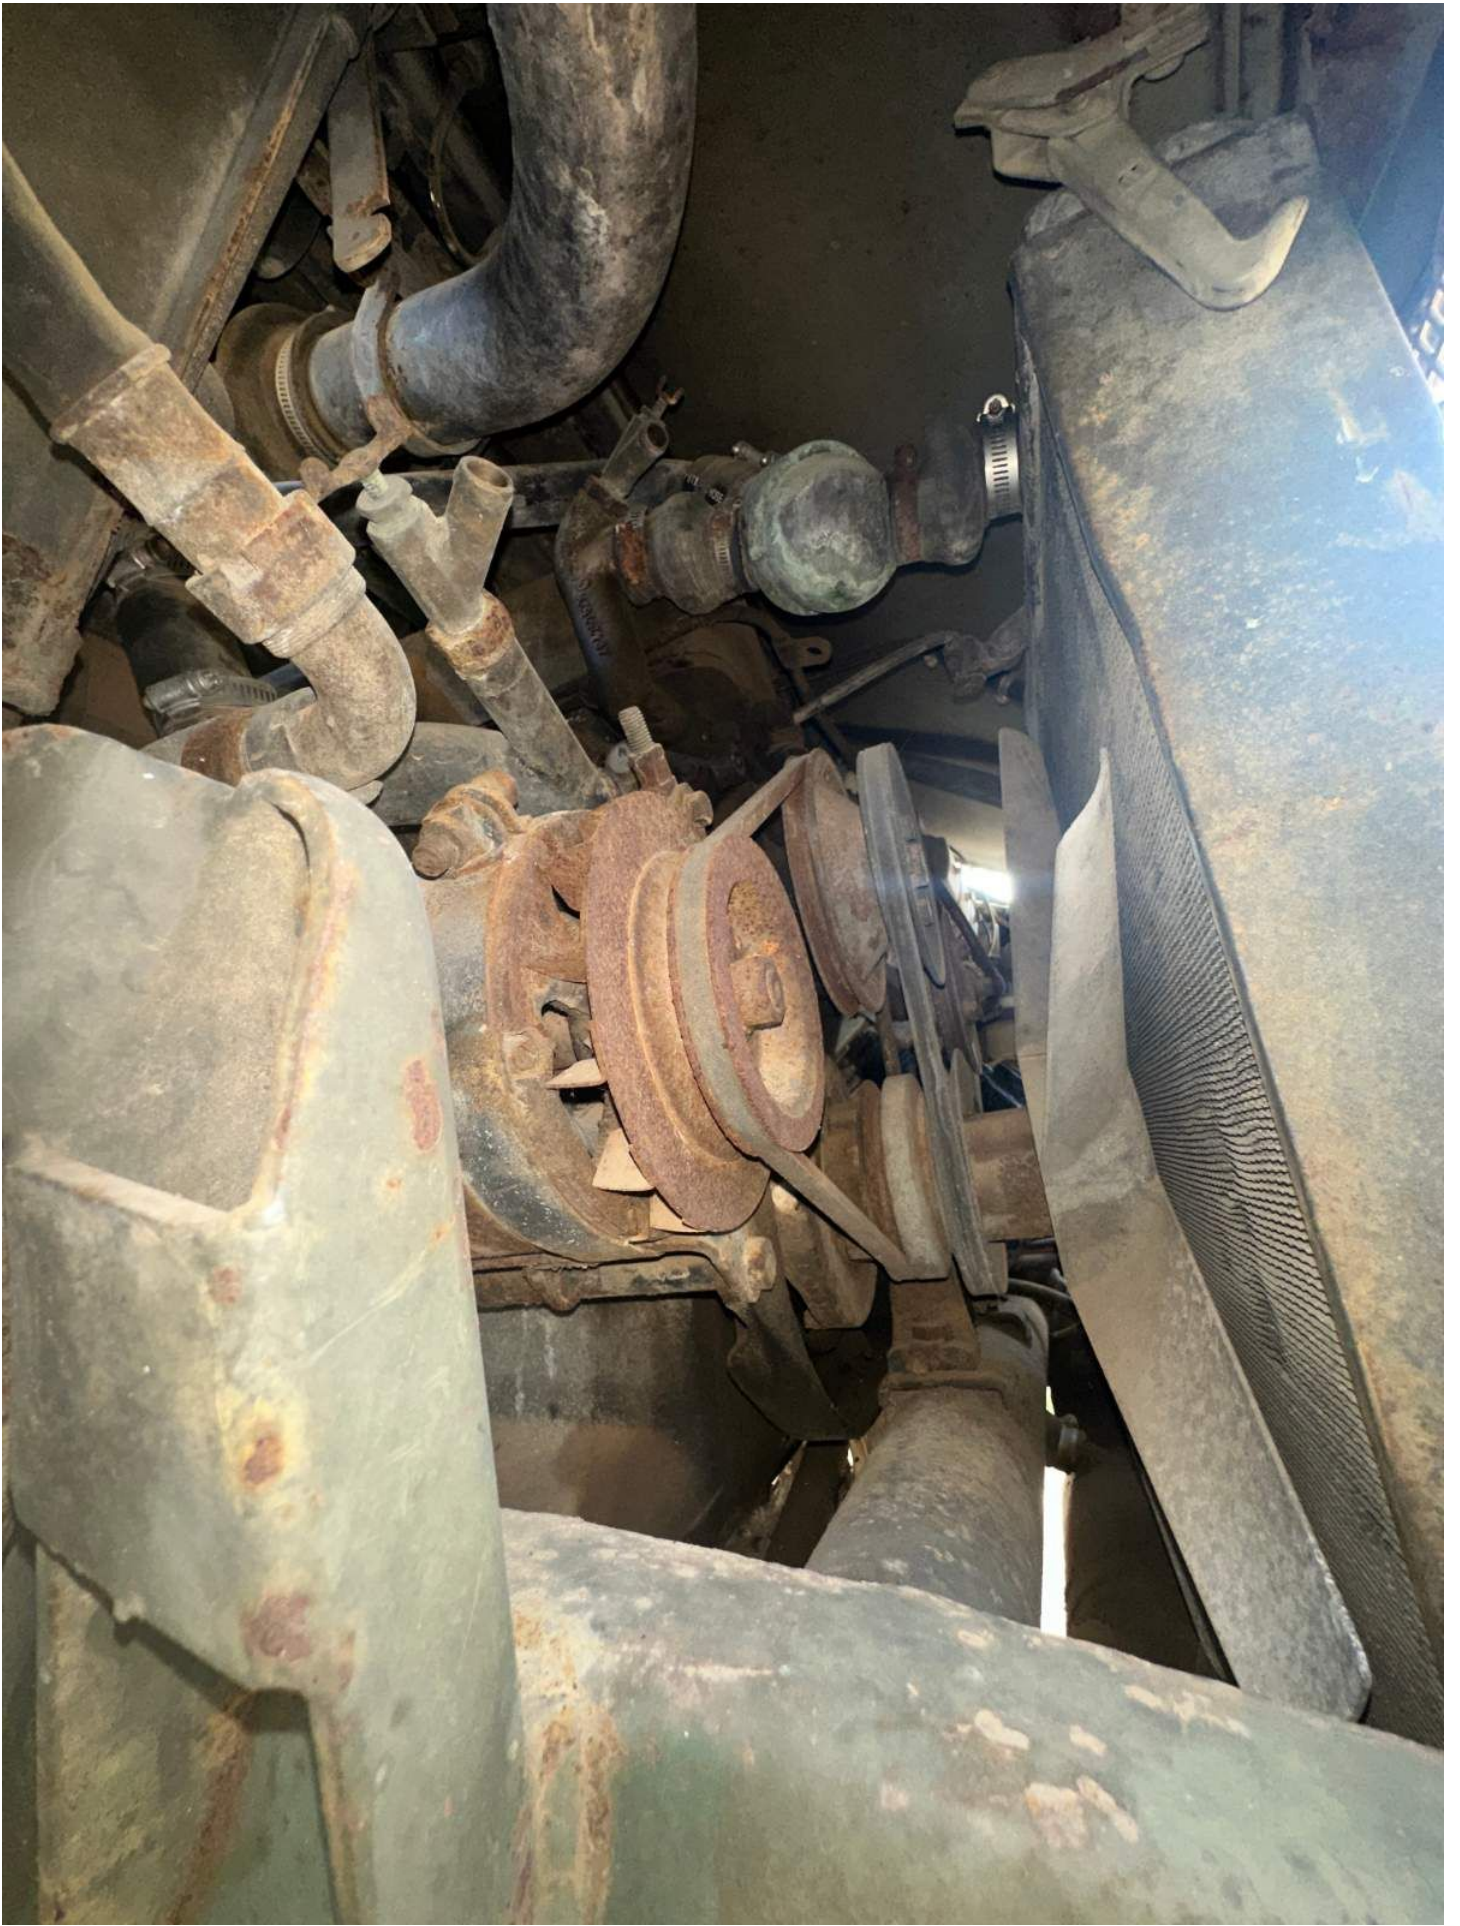
The vin submitted does not match the vin inspected. LO4114-061189 - submitted vin. 404114-061189 - vin inspected. There was not a title present. The odometer was missing during the inspection. This Vehicle has seen a lot of life in a harsh climate and shows signs of concern under close Inspection despite the condition possibly hiding further issues.
