Inspection Report

Report Number: 578050

Date of Inspection: 6/21/2023

1975 Mercedes-Benz Unimog

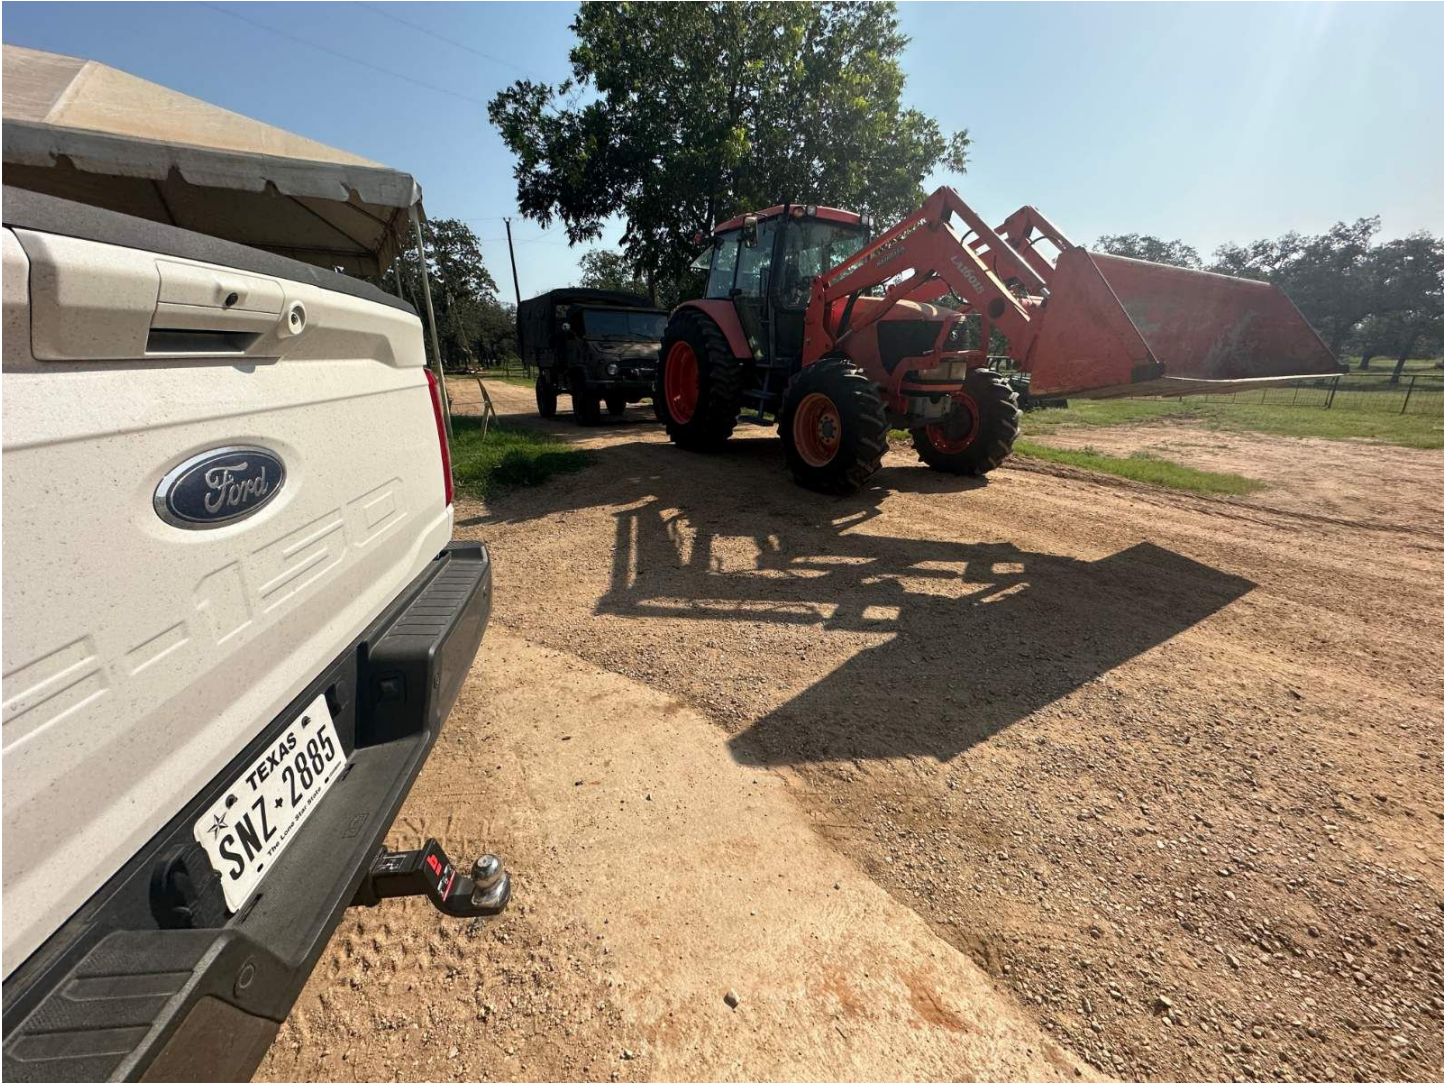
the vehicle had to be towed to a location to do the inspection

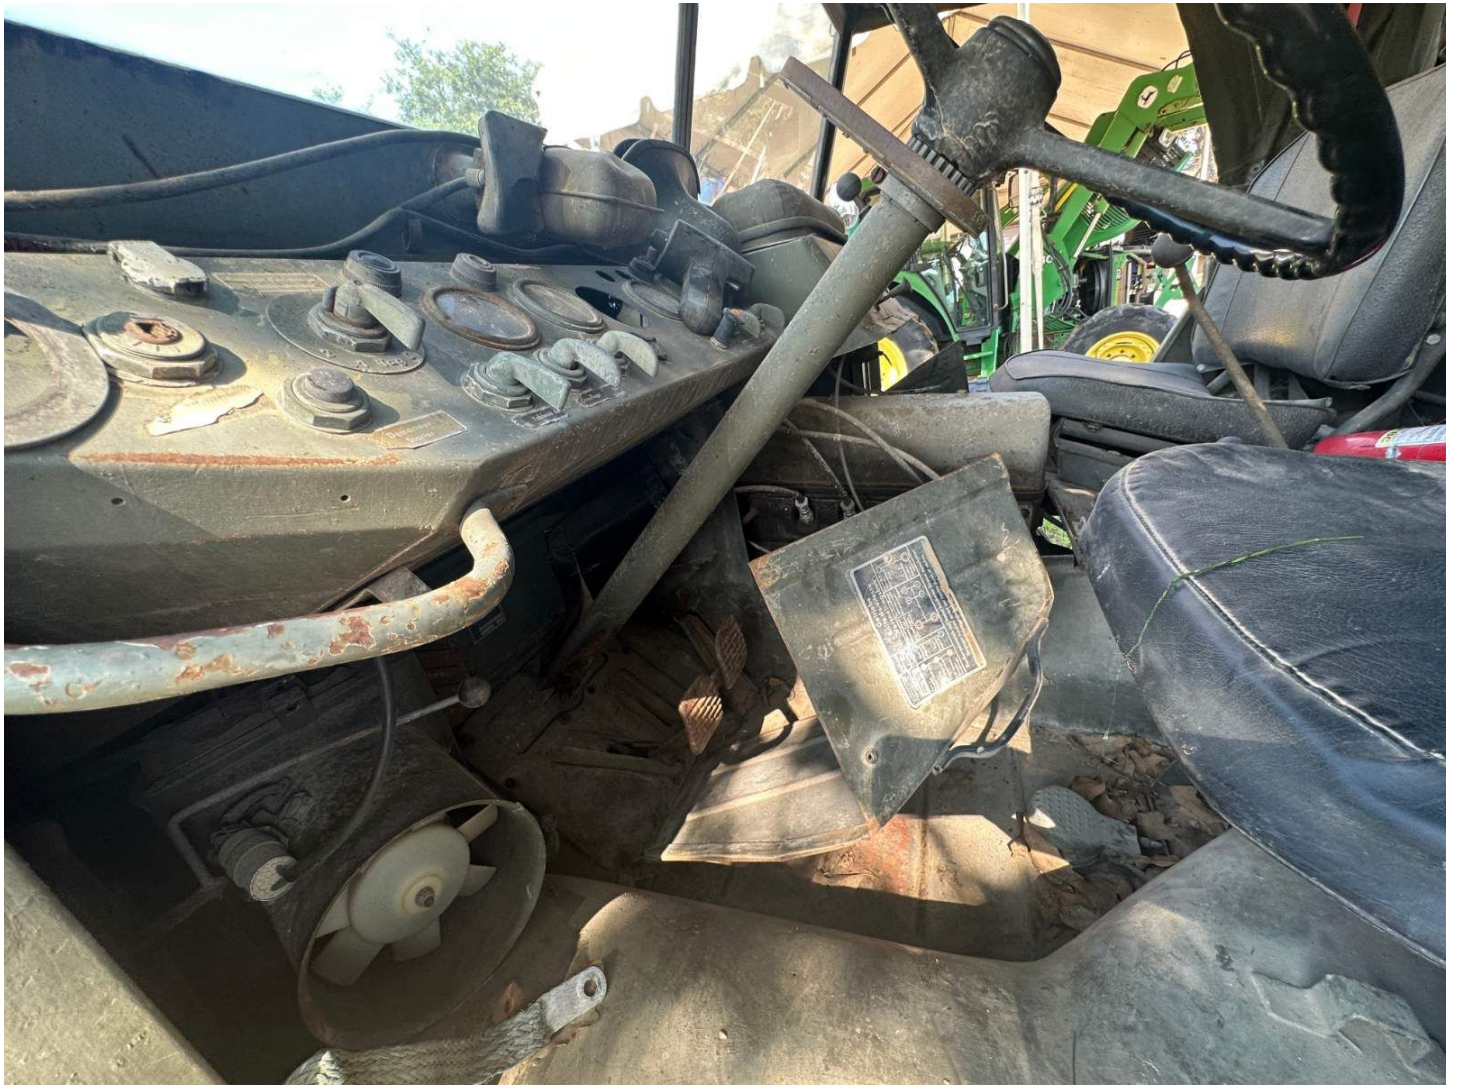
The vin submitted does not match the vin inspected. LO4114-061189 - submitted vin. 404114-061189 - vin inspected. There was not a title present. The odometer was missing during the inspection. This Vehicle has seen a lot of life in a harsh climate and shows signs of concern under close Inspection despite the condition possibly hiding further issues.
