Inspection Report

Report Number: 578050

Date of Inspection: 6/21/2023

1975 Mercedes-Benz Unimog

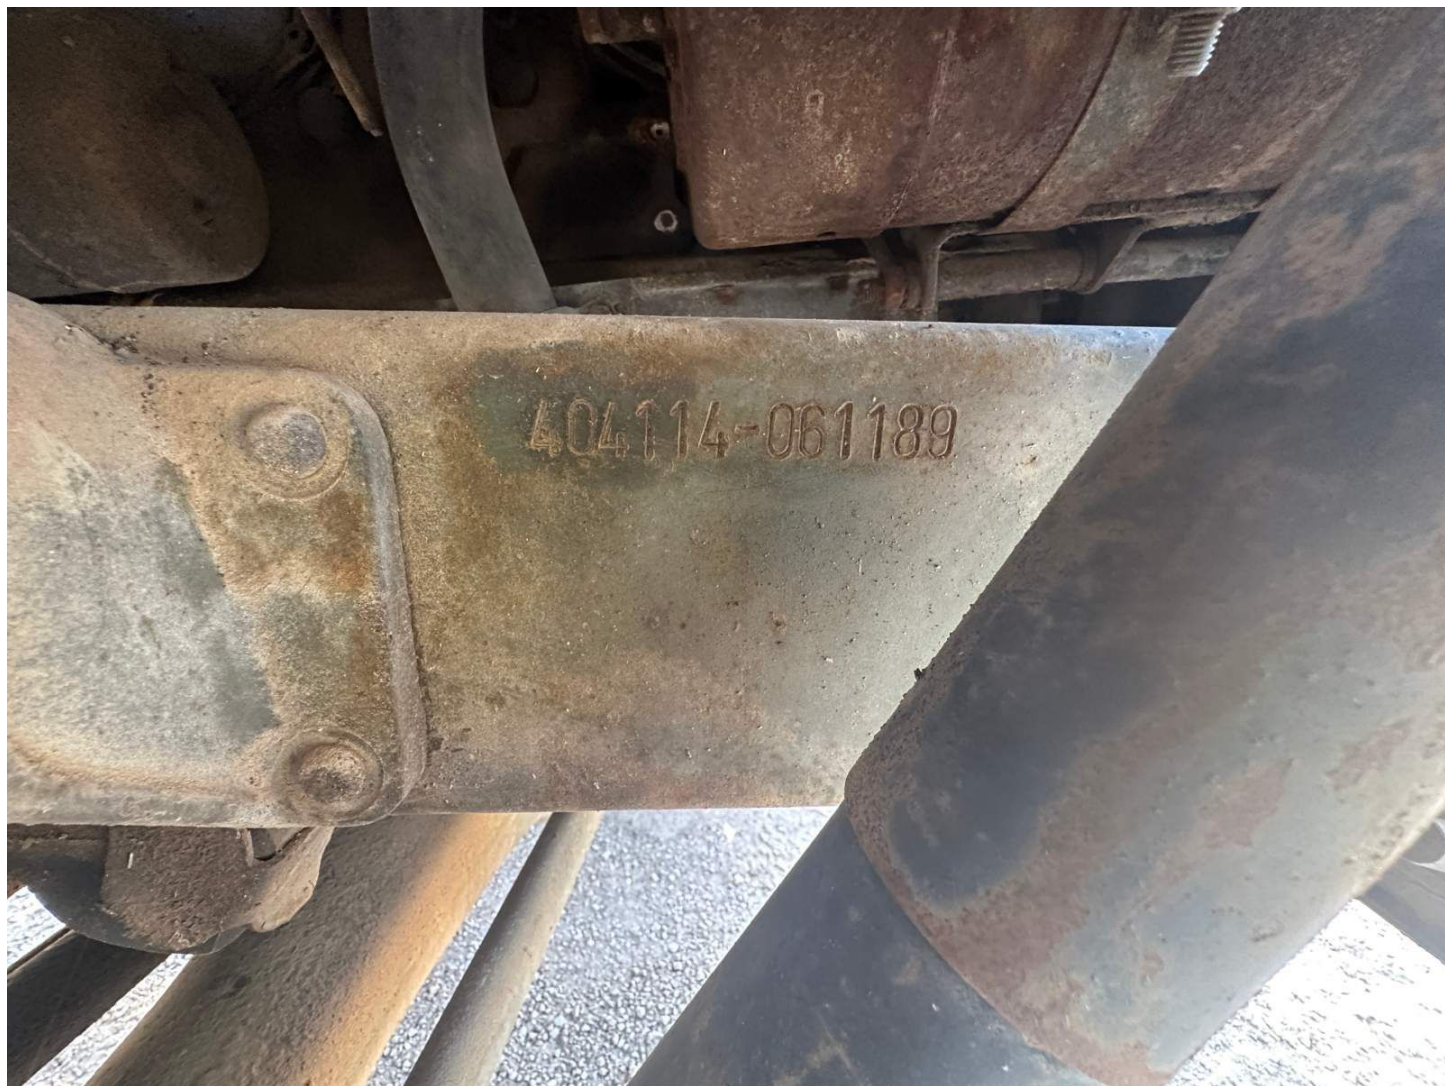
The vin submitted does not match the vin inspected. LO4114-061189 - submitted vin. 404114-061189 - vin inspected. There was not a title present. The odometer was missing during the inspection. This Vehicle has seen a lot of life in a harsh climate and shows signs of concern under close Inspection despite the condition possibly hiding further issues.
