# Inspection Report

Report Number: 564971

1978 Toyota FJ Cruiser

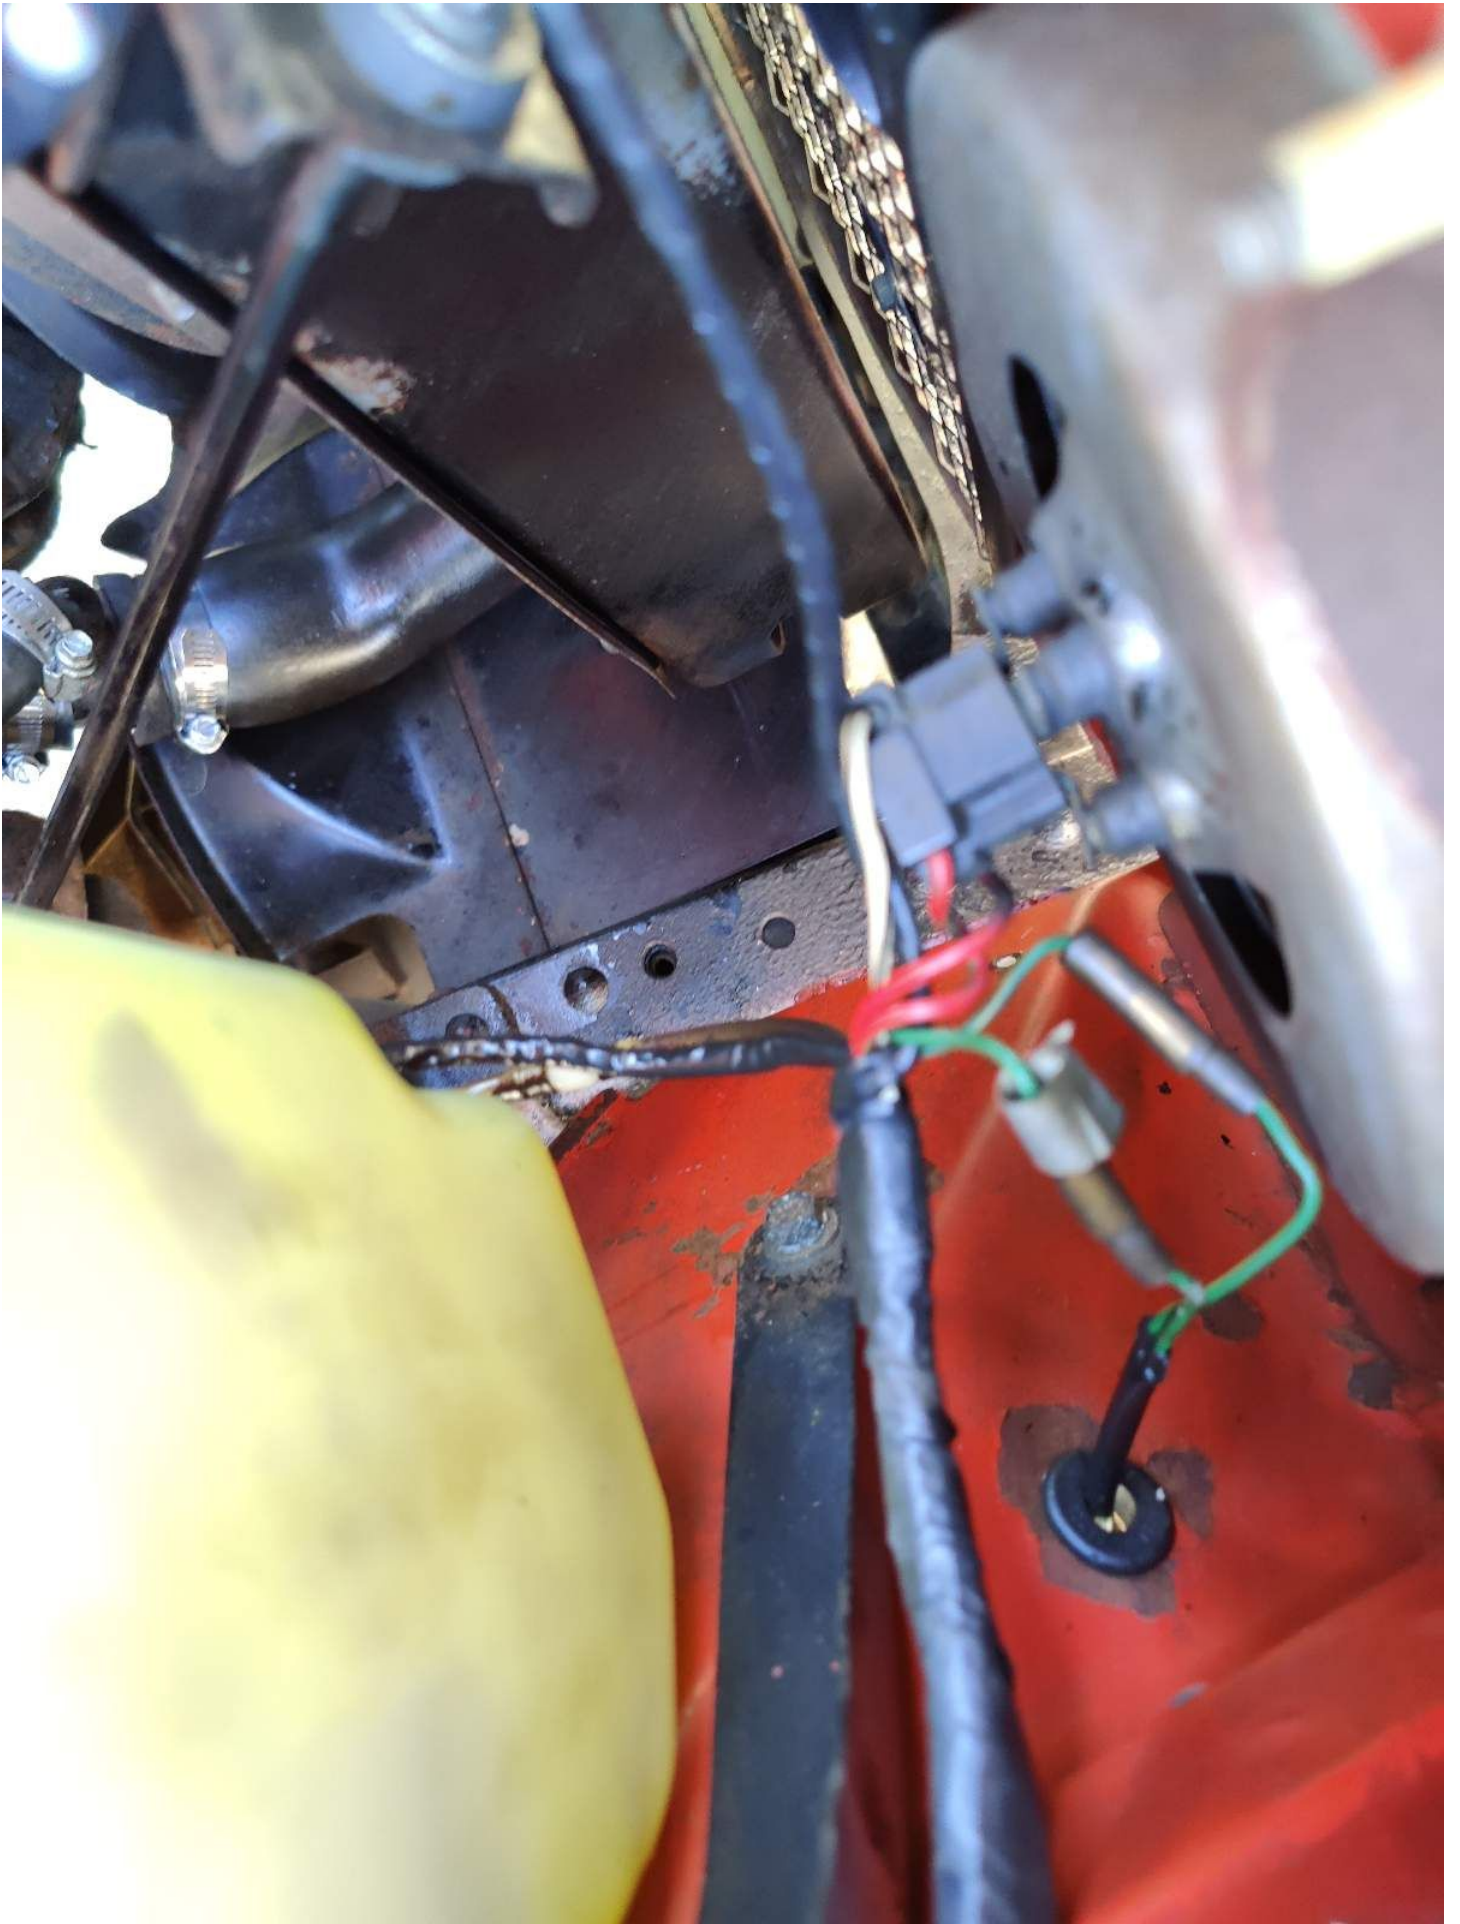
**VEHICLE EMISSION CONTROL INFORMATION**

ENGINE FAMILY 2E(F) 257.9 CID  
 EVAP. FAMILY EV-F  
 EXHAUST EMISSION CONTROL SYSTEM AI-EGR

MAKE ALL ADJUSTMENTS WITH ENGINE AT NORMAL OPERATING TEMPERATURE, CHOKE FULL OPEN, AIR CLEANER INSTALLED AND AIR CONDITIONING OFF.

ENGINE TUNE UP SPECIFICATIONS

IDLE SPEED(RPM)	650(IN)
IGNITION TIMING(BTC)	7° IDLE
IDLE MIXTURE SETTING	LEAN DROP IDLE SET TO THE FOLLOWING VALUE AT BEST IDLE
(SEE REPAIR MANUAL FOR THE PARTICULARS)	TURN IN IDLE MIXTURE ADJUSTING SCREW UNTIL 690 RPM(IN) 650 RPM(IN)
FAST IDLE SPEED(RPM)	1,800 EGR VACUUM RETARD AND EVAP. PURGE OFF.
VALVE CLEARANCE(IN.)	INTAKE 0.008(0.20mm) EXHAUST 0.014(0.35mm)

**TOYOTA MOTOR CO., LTD. NON-CATALYST**

THIS VEHICLE CONFORMS TO U.S. EPA REGULATIONS APPLICABLE TO 1978 MODEL YEAR NEW MOTOR VEHICLES

A  
257.9 cu.in.
