Inspection Report

Report Number: 564971

1978 Toyota FJ Cruiser

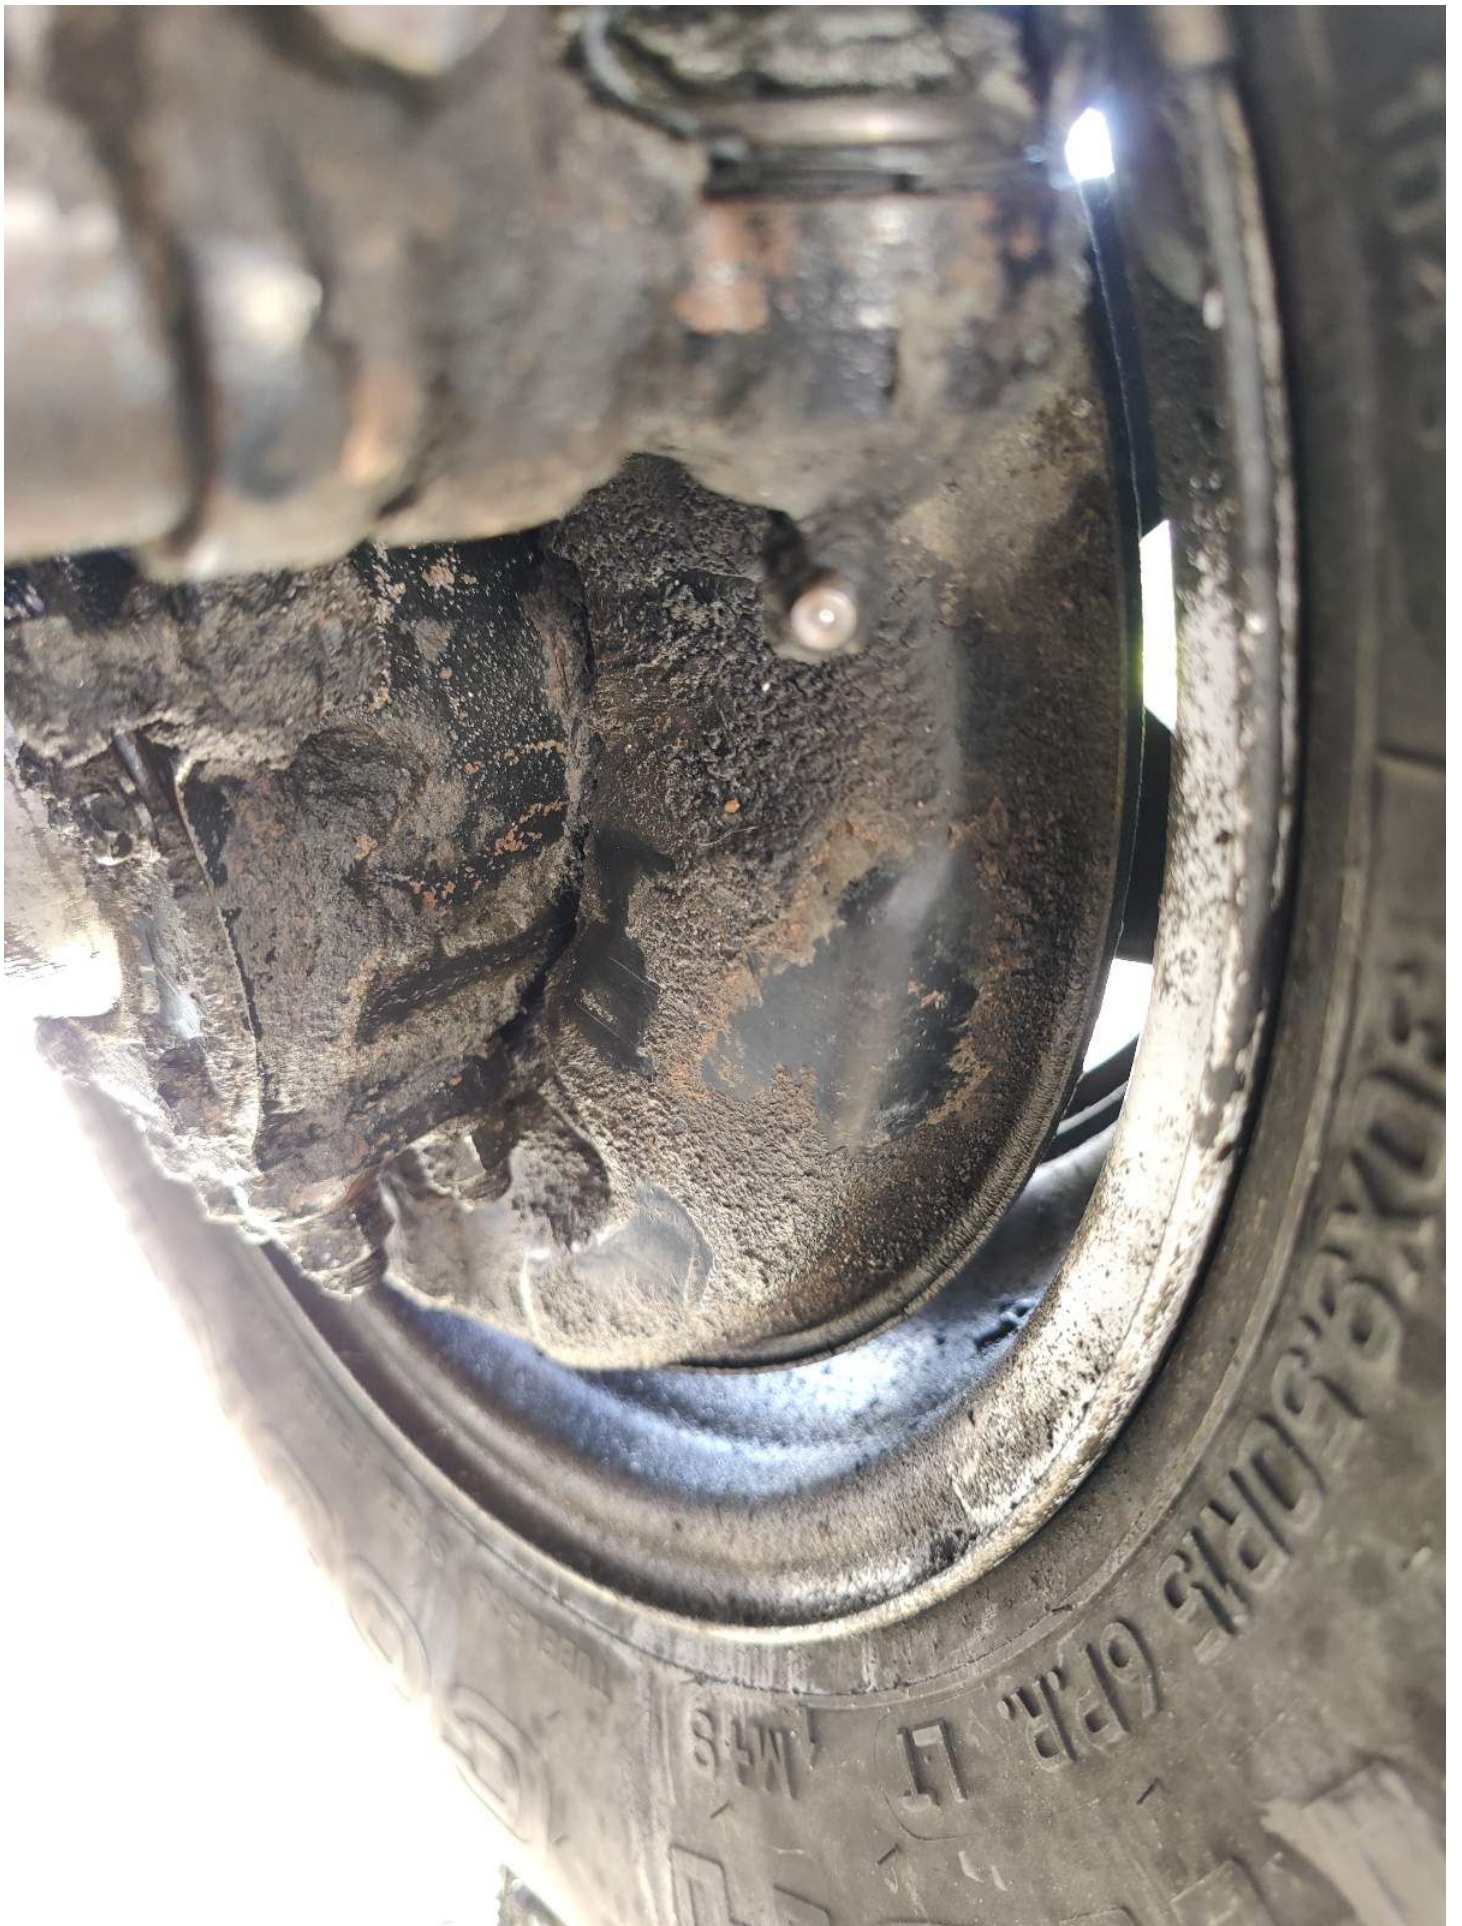
VEHICLE EMISSION CONTROL INFORMATION

ENGINE FAMILY 2E(F) 257.9 CID
 EVAP. FAMILY EV-F
 EXHAUST EMISSION CONTROL SYSTEM AI-EGR

MAKE ALL ADJUSTMENTS WITH ENGINE AT NORMAL OPERATING TEMPERATURE, CHOKE FULL OPEN, AIR CLEANER INSTALLED AND AIR CONDITIONING OFF.

ENGINE TUNE UP SPECIFICATIONS

IDLE SPEED(RPM)	650(IN)
IGNITION TIMING(BTC)	7° IDLE
IDLE MIXTURE SETTING	LEAN DROP IDLE SET TO THE FOLLOWING VALUE AT BEST IDLE
(SEE REPAIR MANUAL FOR THE PARTICULARS)	690 RPM(IN) TURN IN IDLE MIXTURE ADJUSTING SCREW UNTIL 650 RPM(IN)
FAST IDLE SPEED(RPM)	1,800 EGR VACUUM RETARD AND EVAP. PURGE OFF. 650 RPM(IN)
VALVE CLEARANCE(IN.)	INTAKE 0.008(0.20mm) EXHAUST 0.014(0.35mm)

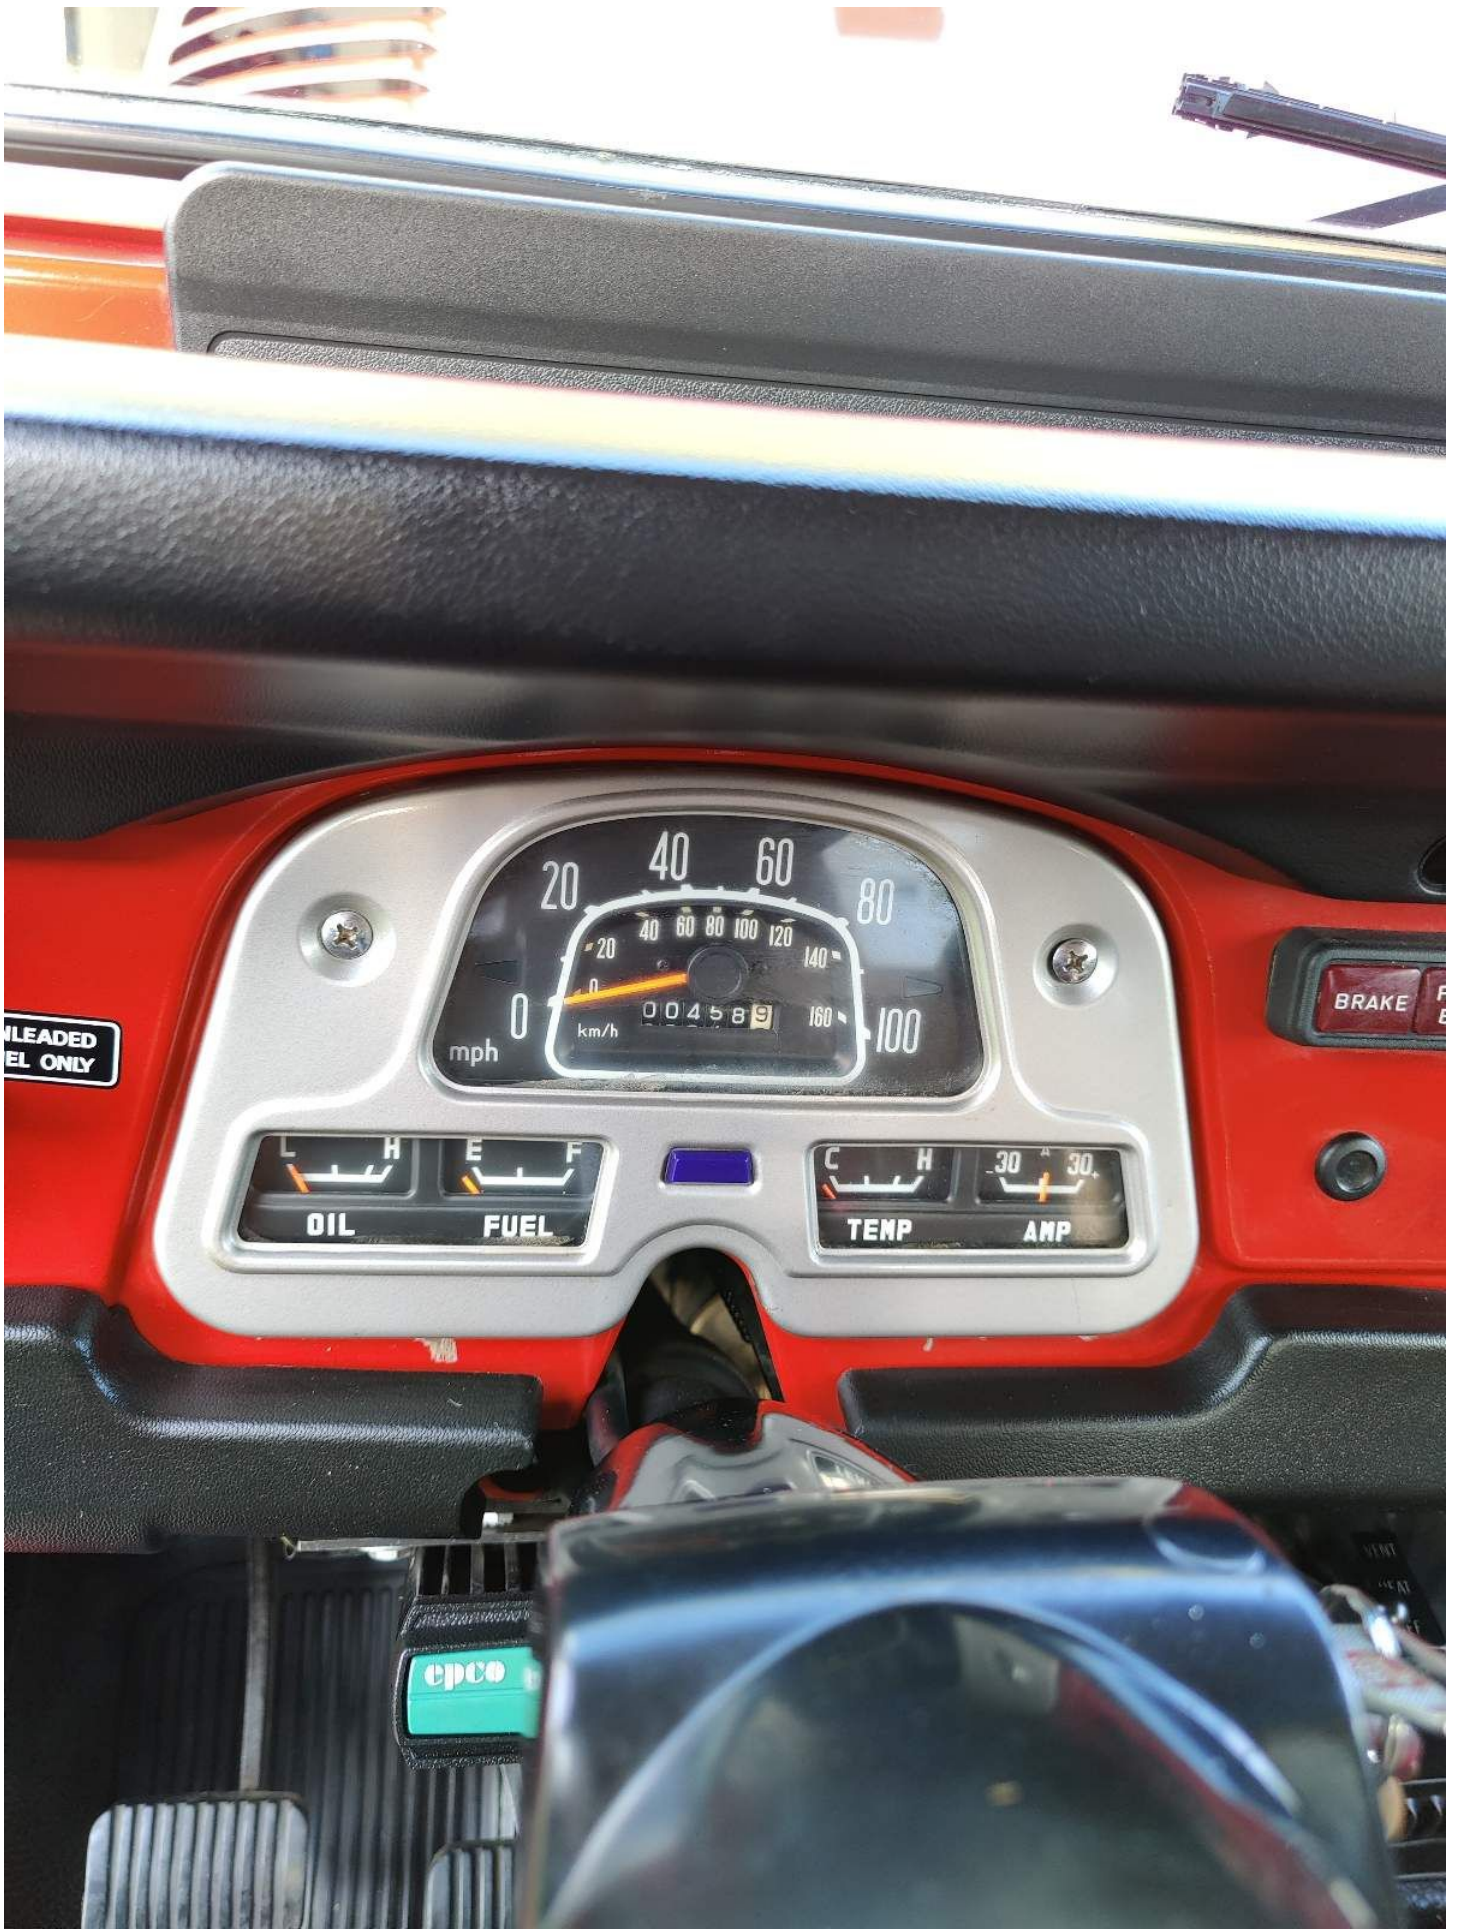
UNLEADED
FUEL ONLY

BRAKE

L H
OIL

E F
FUEL

C H
TEMP
